Final Report

# Survey of savings and conditions of rainwater tanks

10TR4-001. January 2015

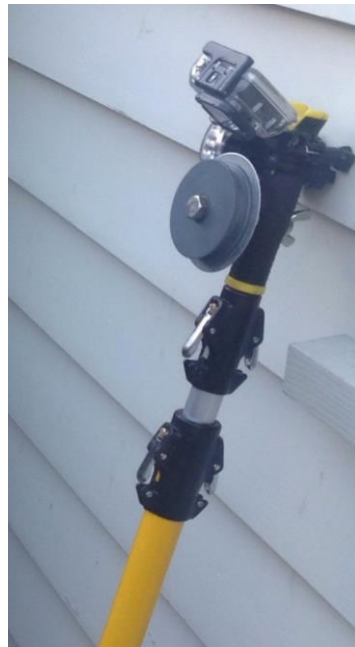
**Figure 2: Mounted Camera, attached above wheel to maintain camera at 200mm above gutter while filming.**

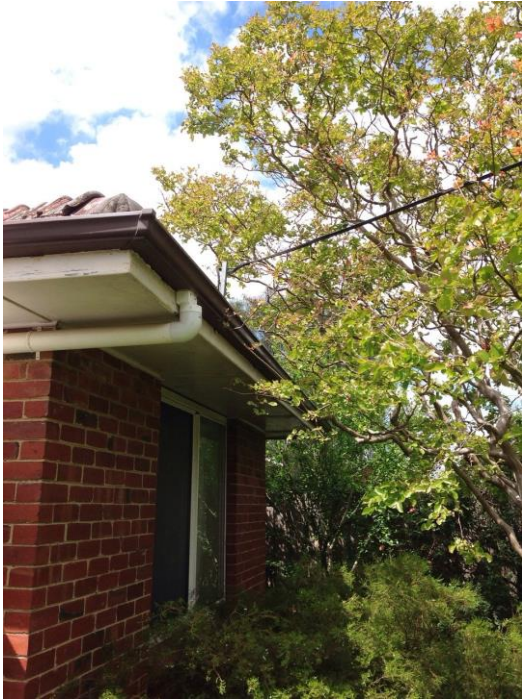
Figure 3: Brick house with tree overhanging roof catchment area.

Initial observations of the local area were recorded and photographed. Observations focused on property details and potential sources of water contamination (Figure 3). The presence of any rainwater use signs, at either property entrance or taps was noted. Other specific observations noted were:

- Roof Area
- Roof Material (Tiles, corrugated iron, etc)
- Lead Flashing (around vents and sunroofs)
- Overhanging trees as per Figure 3 (source of leaves and animal faeces)

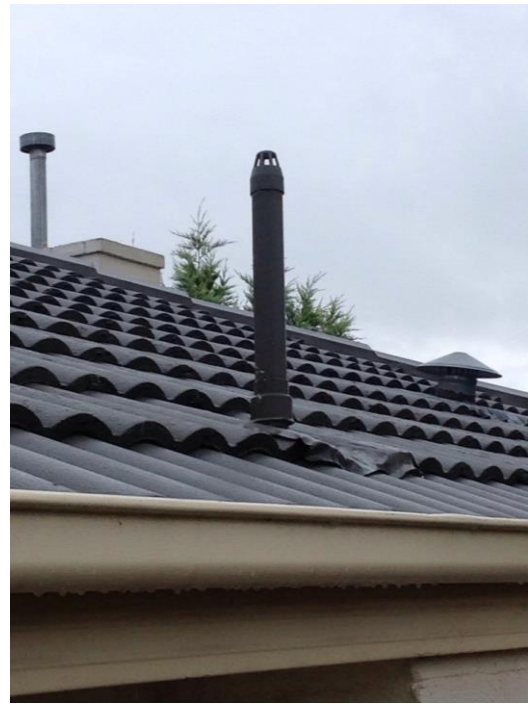
Figure 5: Lead flashing used on air vents.

The rainwater catchment area was visually assessed using a mounted camera. The roof area connected for harvesting was estimated, and the roofing material, any potential sources of lead (Figure 5), leaf debris or animal faeces noted. Specific characteristics noted:

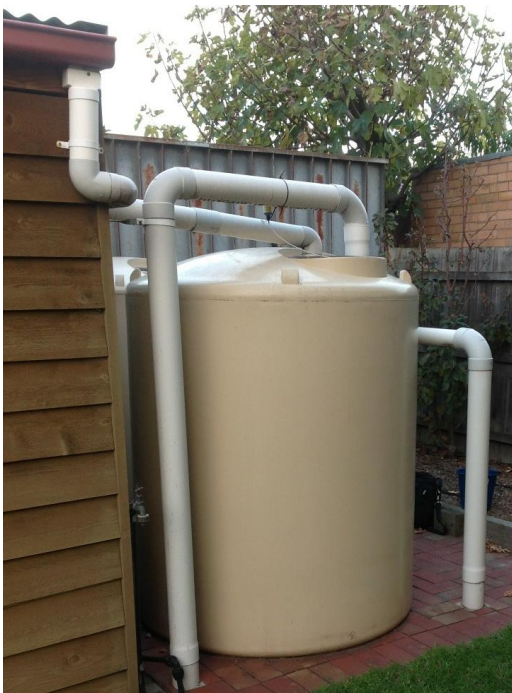
Figure 4: Polycarbonate tank with direct downpipe inflow and wet charge system. Tank installed on pre-existing paving.

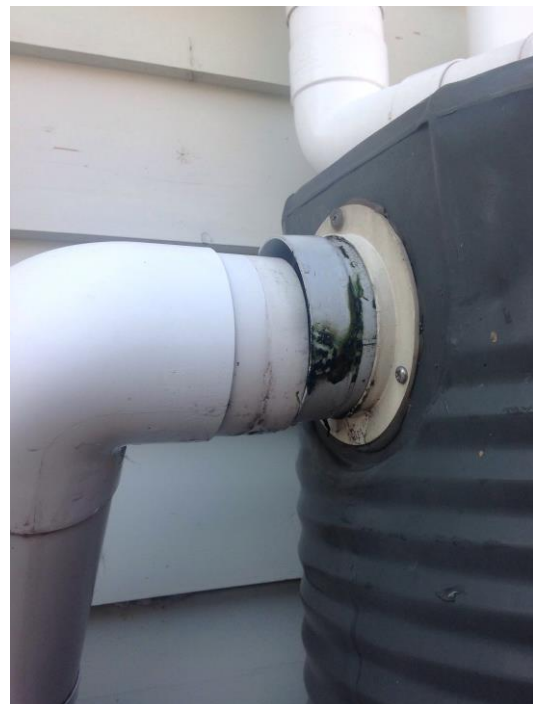
Figure 6: Fouling and leaking around overflow mesh. Disconnection indicates tank may have moved.

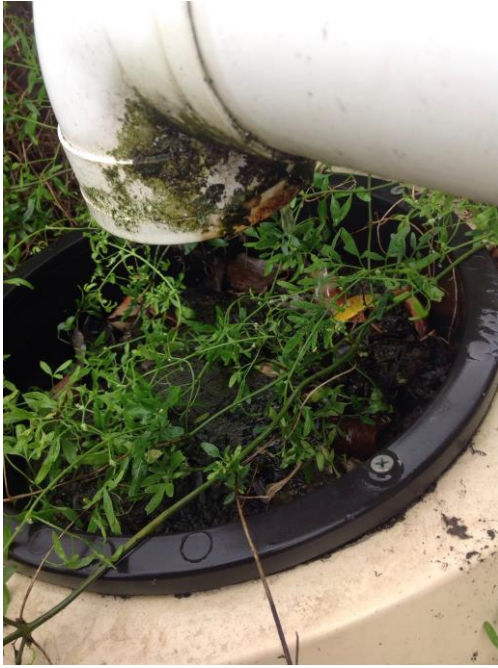
**Figure 7: Inlet filter full of debris and vegetation.**

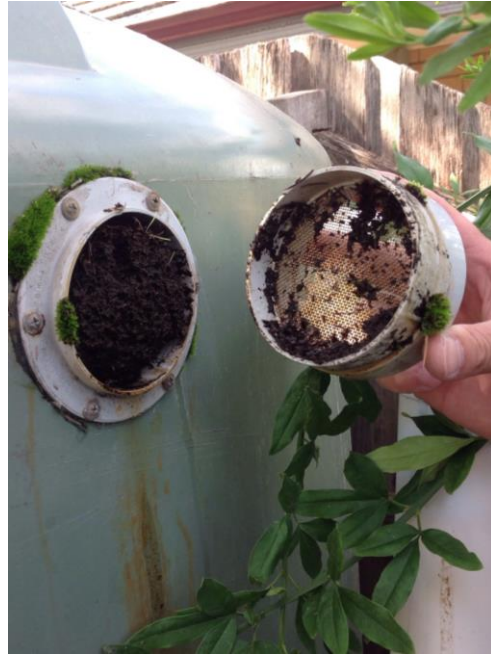
**Figure 9: Fouled mosquito mesh at overflow which indicates high levels of sediment in the tank water.**

The tanks protection against mosquitoes was visually assessed. The condition of screen mesh at inflow, and mosquito mesh at overflow (see Figure 9) was described and any gaps or potential mosquito access identified. When possible, an internal inspection was undertaken to identify the presence of mosquito's, larvae, other insects or animals inside the tank. Other open water vessels in the vicinity were also checked for mosquito larvae.

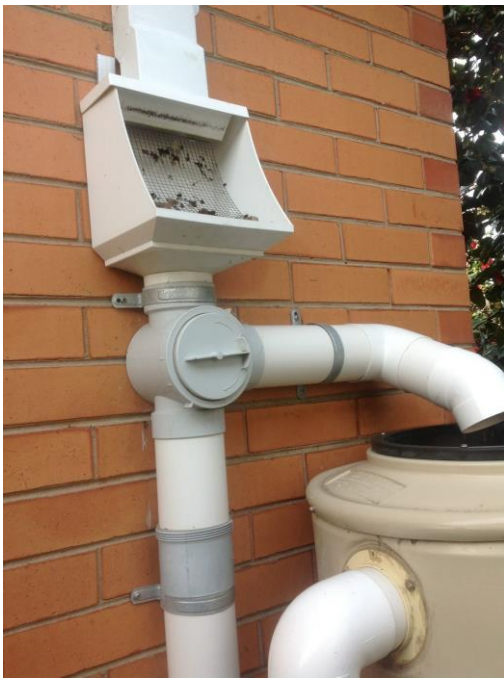
**Figure 8: Rain-head and stormwater switch installed prior to tank inlet.**

- Rain-head, i.e. a container between the gutter and the downpipe that helps the flow of water from the roof and into the tank (see Figure 8).
- Leaf guards: a mesh to protect gutters from filling up with debris.
- First Flush Device: a device to divert the first volume of rainfall, allowing for dirt and other contamination that has accumulated on the roof to be diverted away from the tank.
- Tank guardian: additional tank screen which is easily removed and thus allowing for easy cleaning.

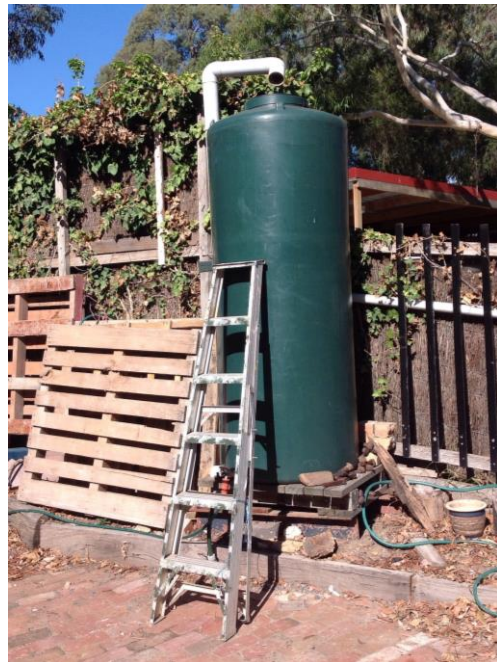
**Figure 10: High-risk set-up. High center of gravity, non-concrete base, pallets and ladder at risk of falling, hose is a tripping hazard.**

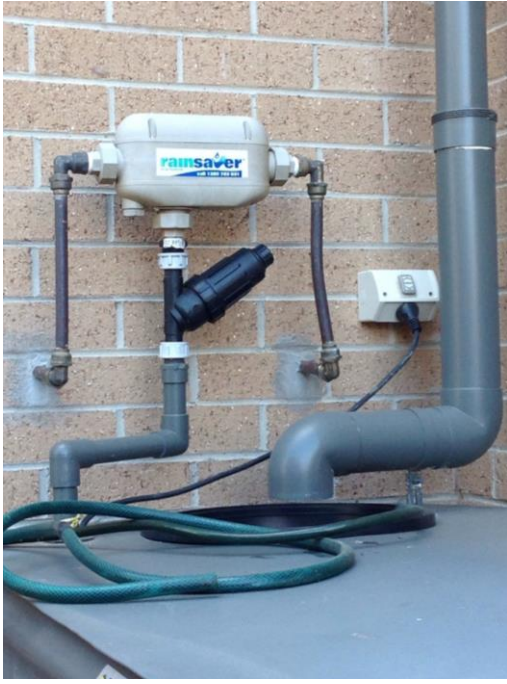
Figure 11: Electronic diverter and in-tank sump-pump with filter.

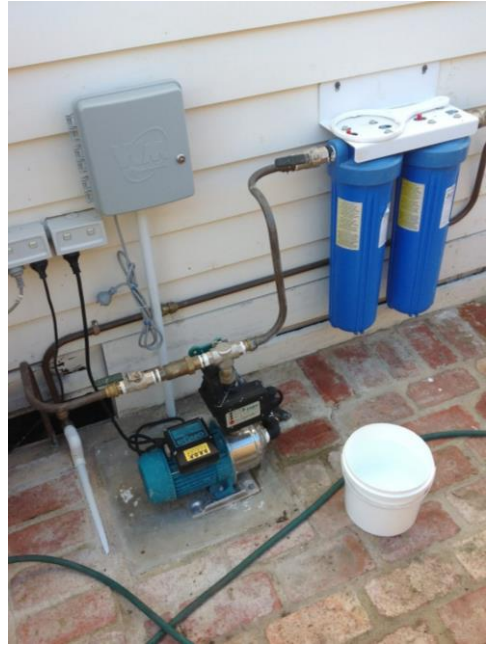
Figure 13: Pump system with copper piping and dual filters (pump enclosure not visible).

Where present, the tank's pump was visually assessed, manually tested and photographed (Figure 12 and Figure 13). The pumps were checked by running them, after ensuring that power was supplied and that the pump had adequate water supply from tank (e.g. ball valve between tank and pump was open). Subsequently, a tap connected to outlet was opened or for in home connections the occupant was asked to flush the toilet. With the pump running it was checked for leaks and noises (bearing noises) or friction. Then the inspector ensured that the pump stopped running when water taps were off. There was also a check for water damage to the pump e.g. if the pump was positioned in a low area prone to flooding there was usually a trace of previous water line.

The pumps details were noted from the manufacturer's label. The height of the water intake from the tank was measured, and the diameter and condition of the pipe-work was noted. The pump was tested and issues identified by pumping water for 10 seconds. A visual inspection of the pump enclosure was undertaken to determine effectiveness of sound isolation and presence of weather protection (Figure 13). By talking with survey participant, the history of the pump was ascertained.

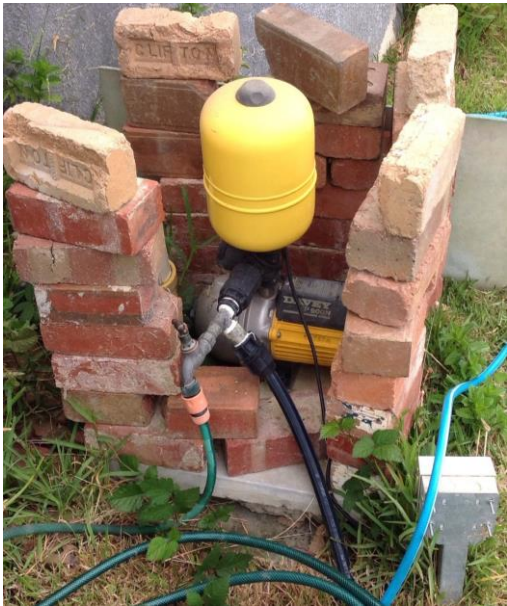
Figure 12: Pump with pressure vessel.

- Inline filters
- Pressure vessels (see Figure 12)
- Mains water diverters (electronic, manual, see Figure 11)
- Mechanical float switch

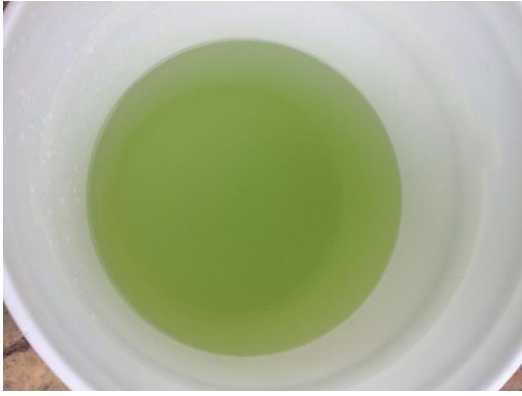
**Figure 14: Light green water sample indicates high levels of algae.**

A sample of water was taken from the tank outlet and its quality assessed. To ensure sample was representative of tank water, the initial 10 seconds of flow were discarded. A white 10L bucket was then half filled and its odour, colour and particulate concentration was visually assessed and the sample photographed (see Figure 14, Figure 15, Figure 16, Figure 17 and Figure 18).

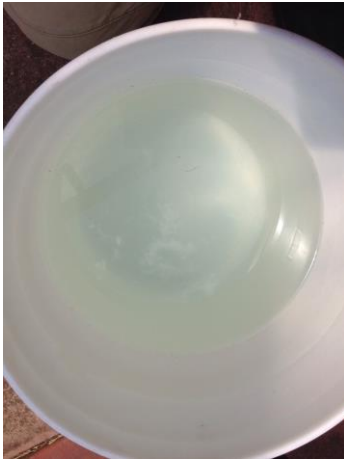
**Figure 15: Clear sample indicates high quality water.**

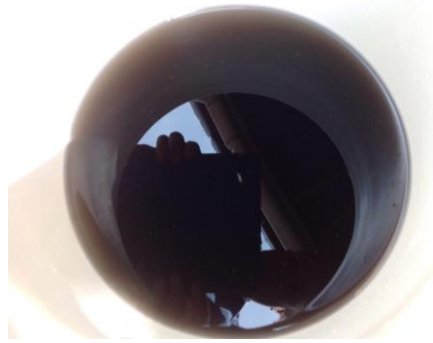
**Figure 18: Black sample indicates anoxic water, high levels of organic matter in tank.**

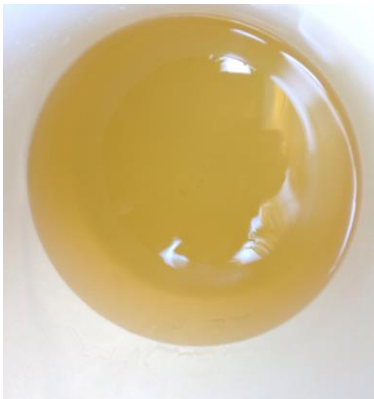
**Figure 16: Light brown sample indicates high levels of tannin.**

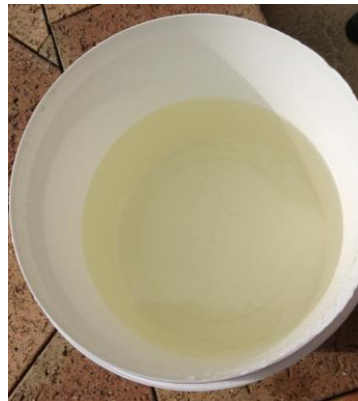
**Figure 19: Picture of water in white bucket, light brown colour indicates tannins from leaves.**

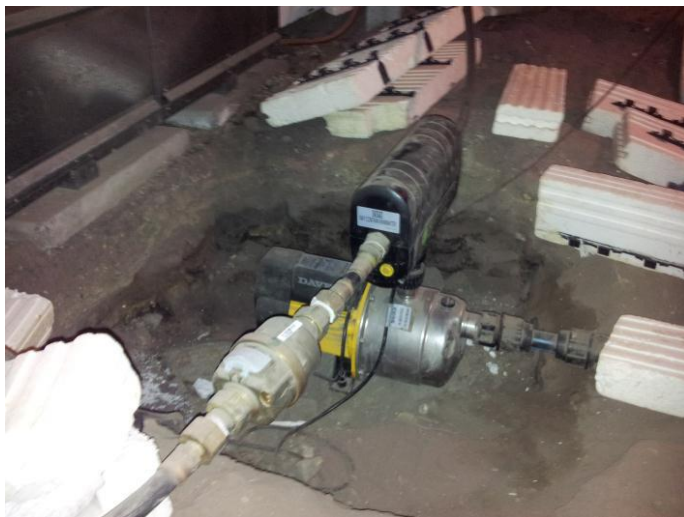
**Figure 21: Equipment installed at a second study site**

**Note:** This is a pump and Rainbank (water diverter switch), which determines when the rainwater tank is empty, to source water from the main pipe. The 20mm PSM meter is measuring all water flow out of the tank. The loggers are not in the picture.

Flow metering equipment has been installed as per set-ups shown in *Appendix I* by the company BMT WBM<sup>4</sup> according to plumbing regulations, and as per photograph in Figure 21 to Figure 24. Meters/loggers have been installed on pumps as per Figure 22. In a number of sites, depth probes

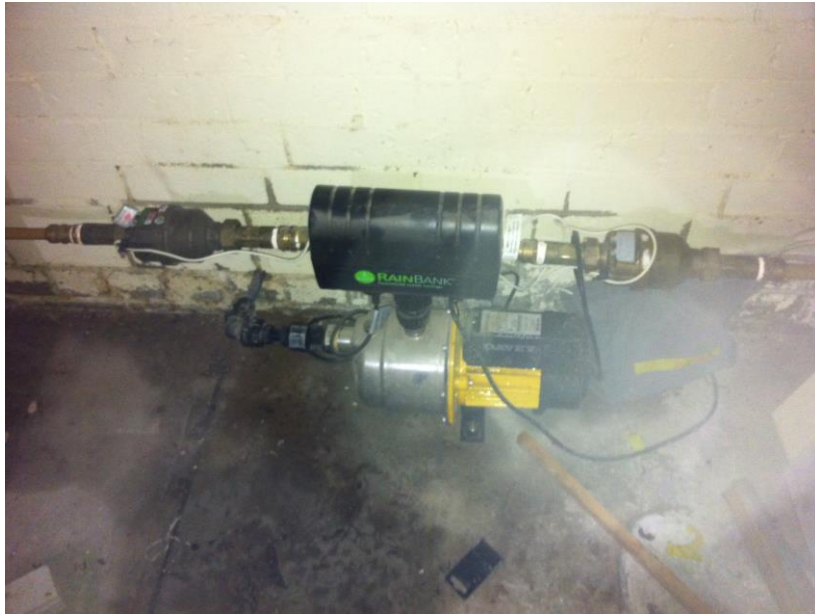
Figure 22: Photo of a pump with meters

**Note:** This photo of the pump shows the meters on the main inlet and all water out. The logger is inside the grey bag to the right, a bit clouded by the water on the camera lens.

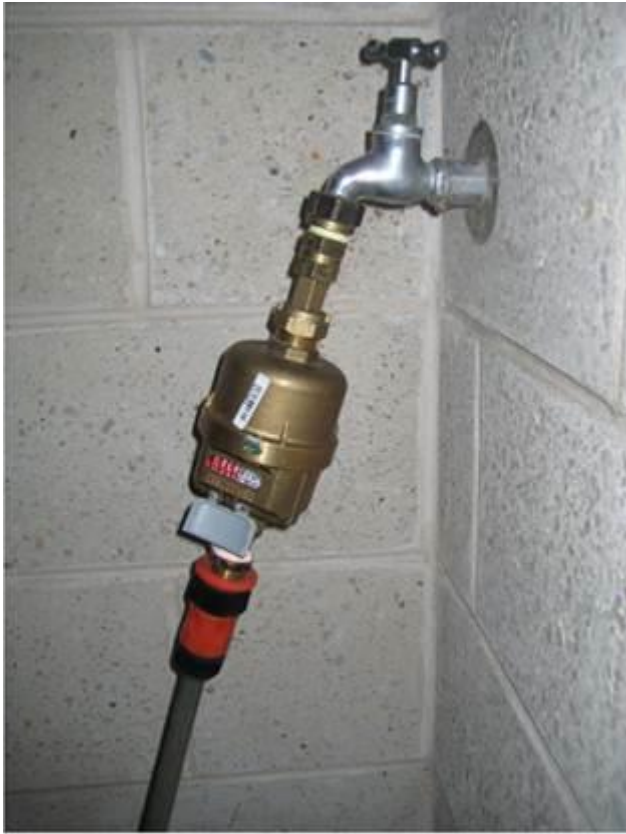
Figure 24: Flow meter connected to garden tap

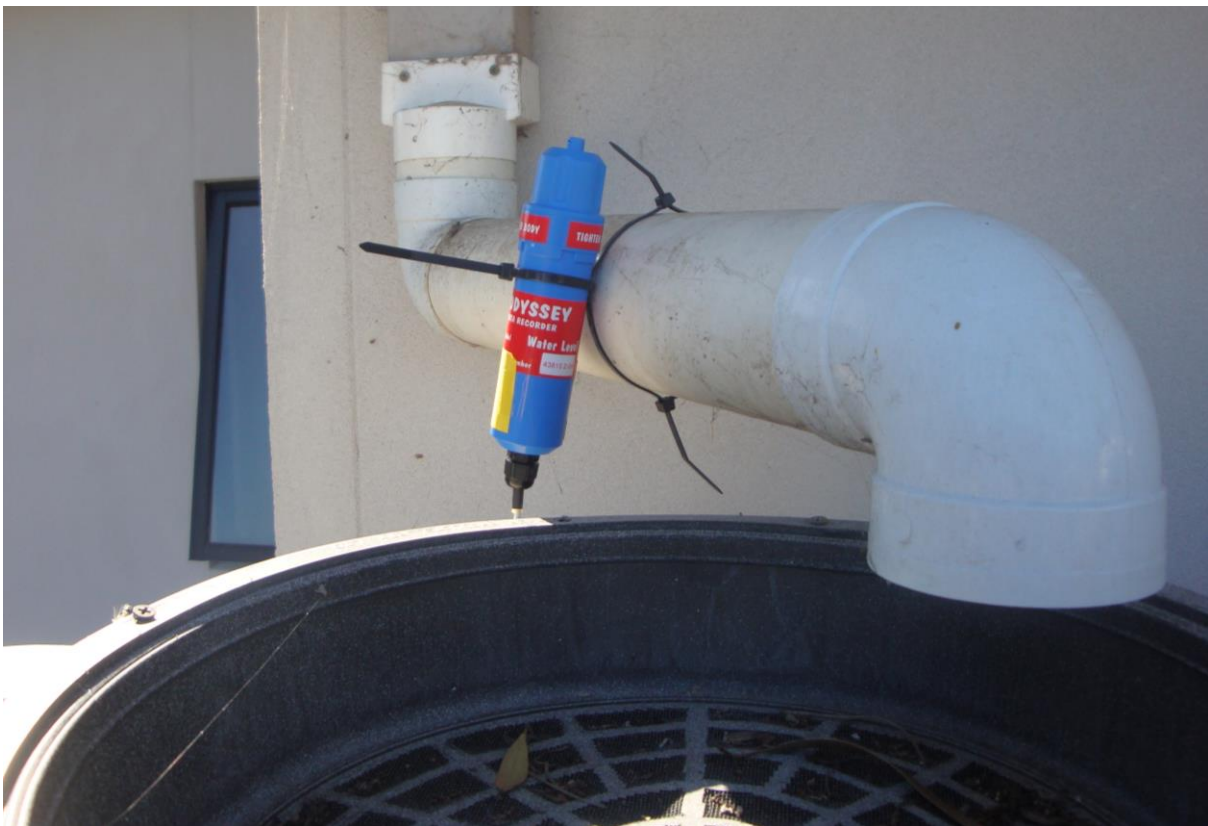
Figure 25: Depth gauge connected to tank

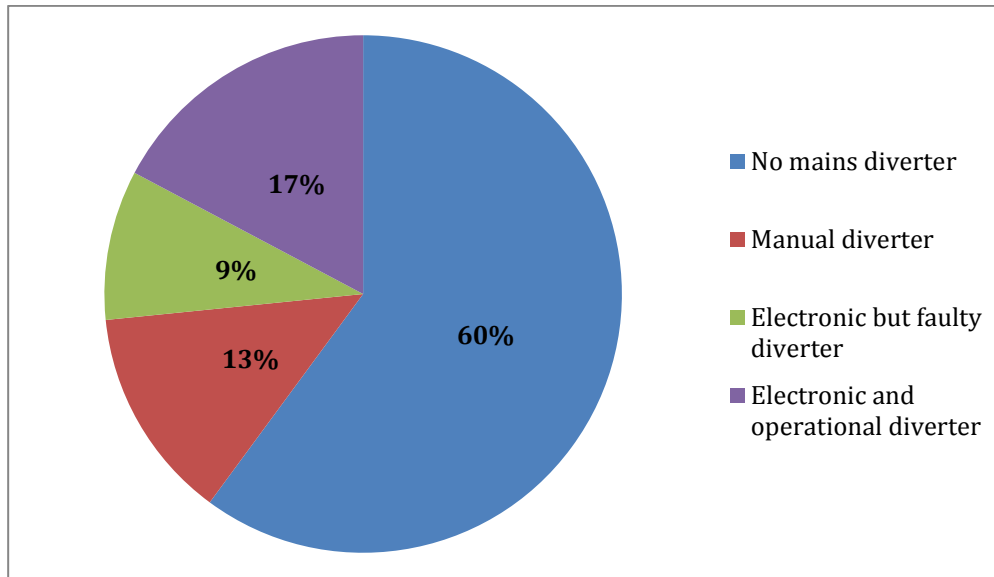
Type of diverter	Number of sites	Number of these with failure history	Number of these currently broken	Failure rate	Currently non-operational
Manual	27	0	0	0%	0%
Electronic	54	28	19	52%	35%
None	122	N/A	N/A	N/A	N/A
Total	203	N/A	N/A	N/A	N/A

Figure 34: Summary of diverter information - percentages of diverter types and functionality
