Smart Water Fund

Final Report

Survey of savings and conditions of rainwater tanks

10TR4-001. 18th September 2014

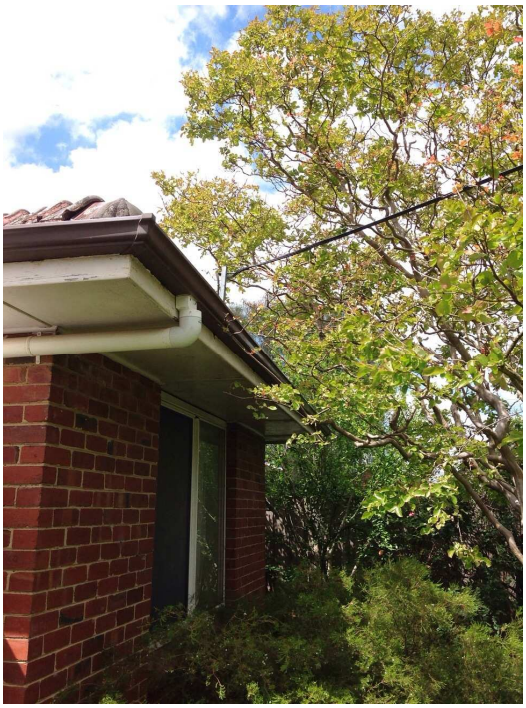
Figure 3: Brick house with tree overhanging roof catchment area.

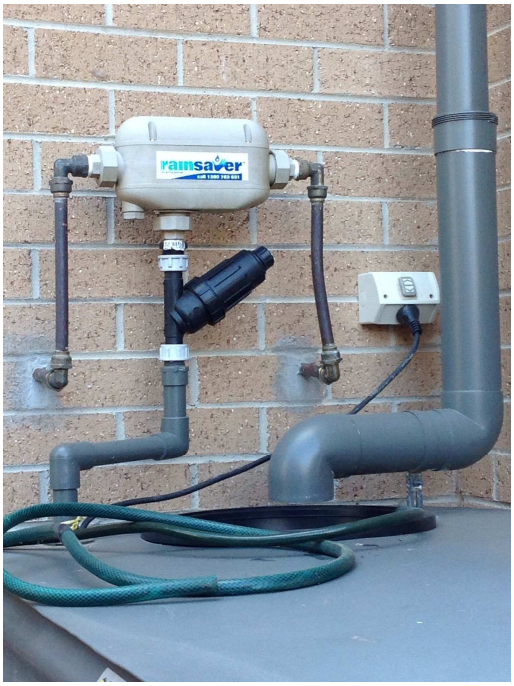
Figure 10: High-risk set-up. High center of gravity, non-concrete base, pallets and ladder at risk of falling, hose is a tripping hazard.

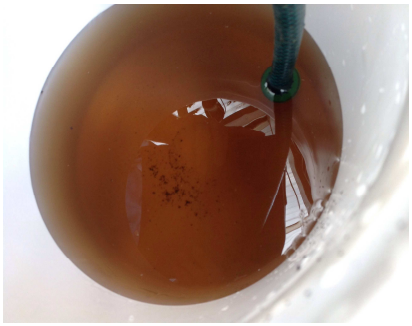
Figure 17: Dark brown sample indicates high levels of sediment and tannin.

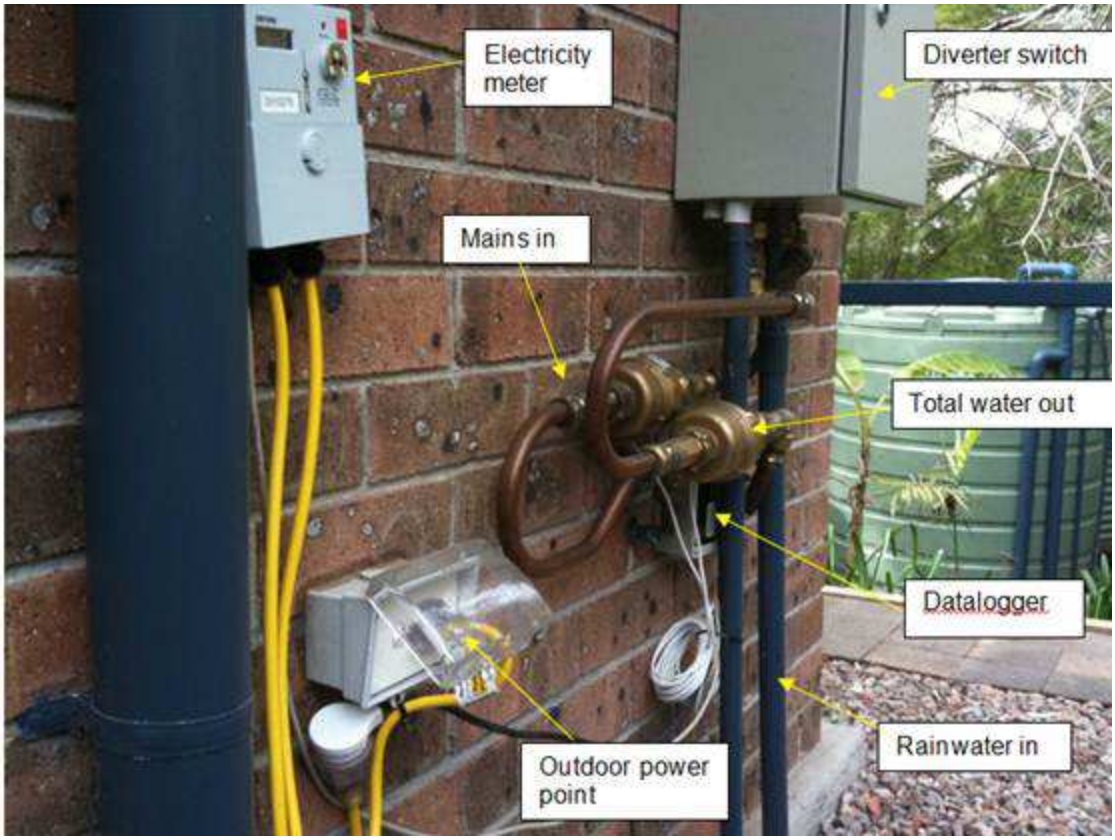
Figure 23: Setup of flow meters and data loggers in site

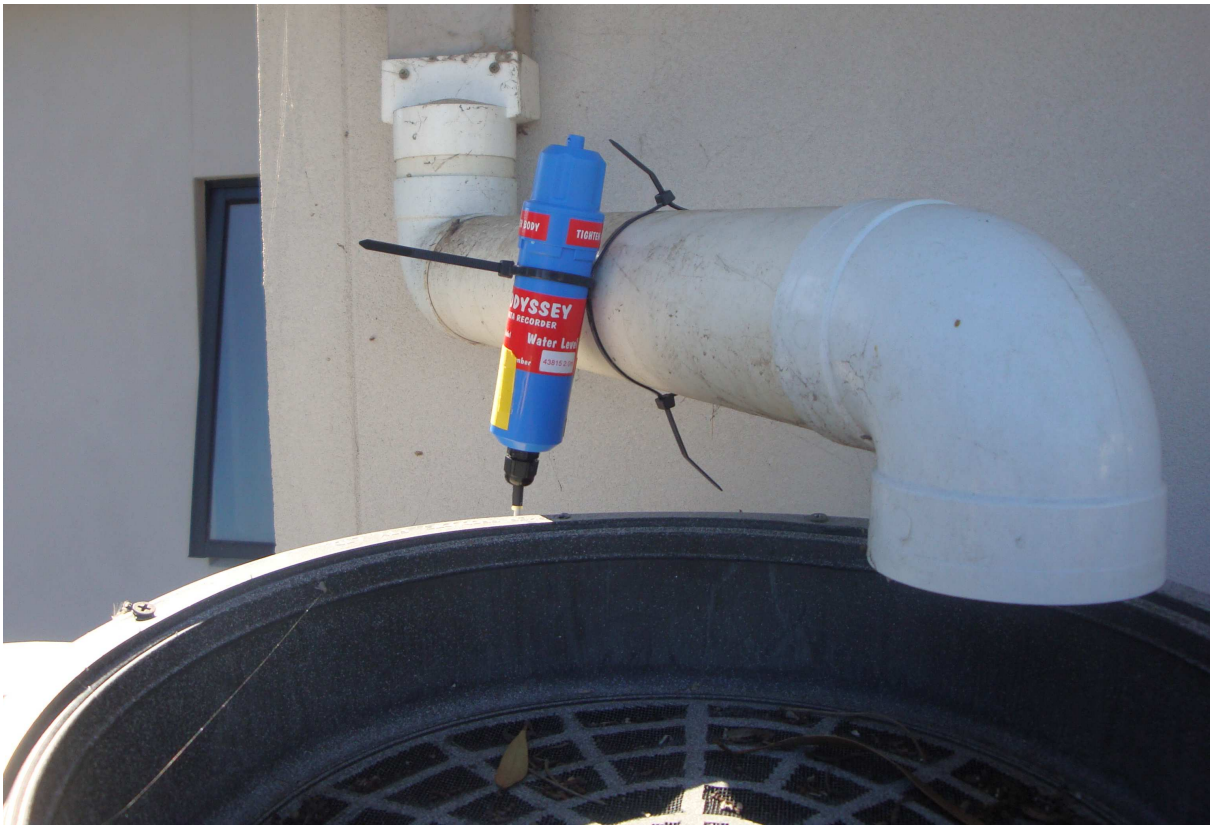
Figure 25: Depth gauge connected to tank

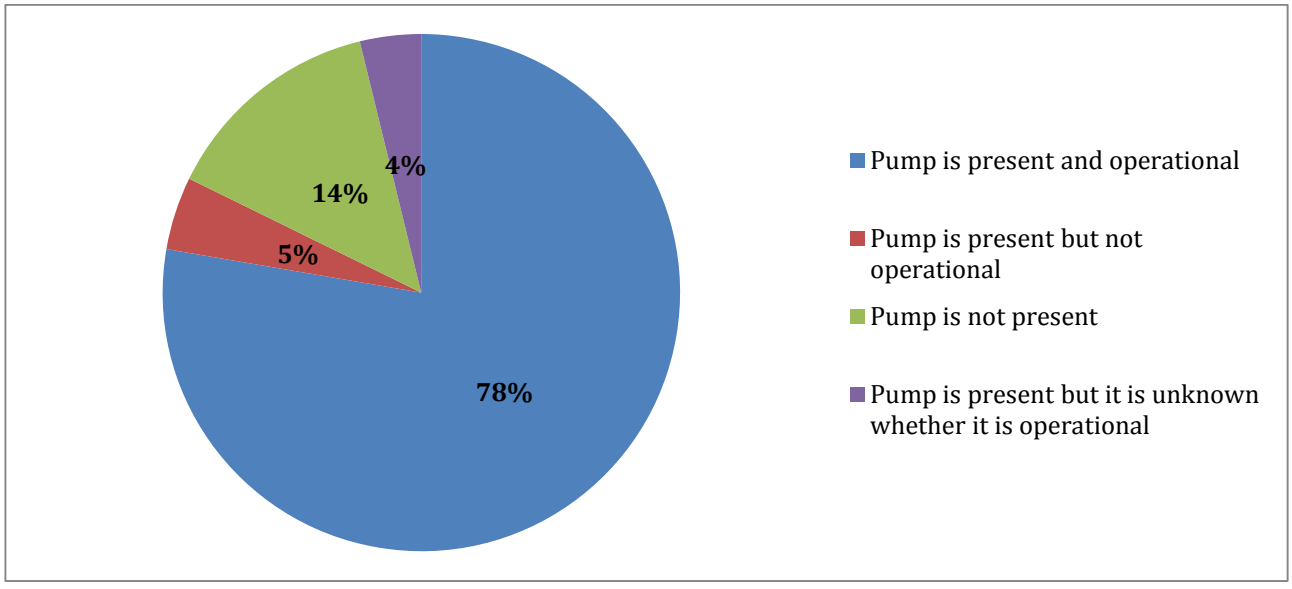
The condition and operation of pumps and diverters are essential to ensure that a dwelling is able to use rainwater at satisfactory service levels. Pumps were installed in 86% of dwellings, whilst 14% of dwellings adopted gravity-based systems. Among dwellings with pumps 90% were operational, 5% we not functioning and 4% could not be determined as the householder was not home at the time of inspection (Table 14). Of the tanks that were present, approximately 90% were operational at the time of installation (Table 15). Figure 33 summarizes this information to show the distribution of situations in different sites. Sixty-three percent of installations still had the original pump that was installed with the tank, however 13% experienced pump failure and had either purchased a new pump, had it repaired or removed altogether (Table 16). Among the tanks with pumps, 77% were tested for abnormal noises and 80% for leaks, the remainder could not be tested because of lack of water in the tank or because the pumps were not working (Table 17). Among that majority were in good condition: only 3% had abnormal noises, however 18% leaked. Approximately 21% had no pump enclosure, 31% could not be determined or examined due to access restrictions, however the remaining 46% were in good or fair condition and only 2% were in poor condition (Table 18). However, a greater concern

Figure 33: Proportions of tank systems with presence and condition of pumps

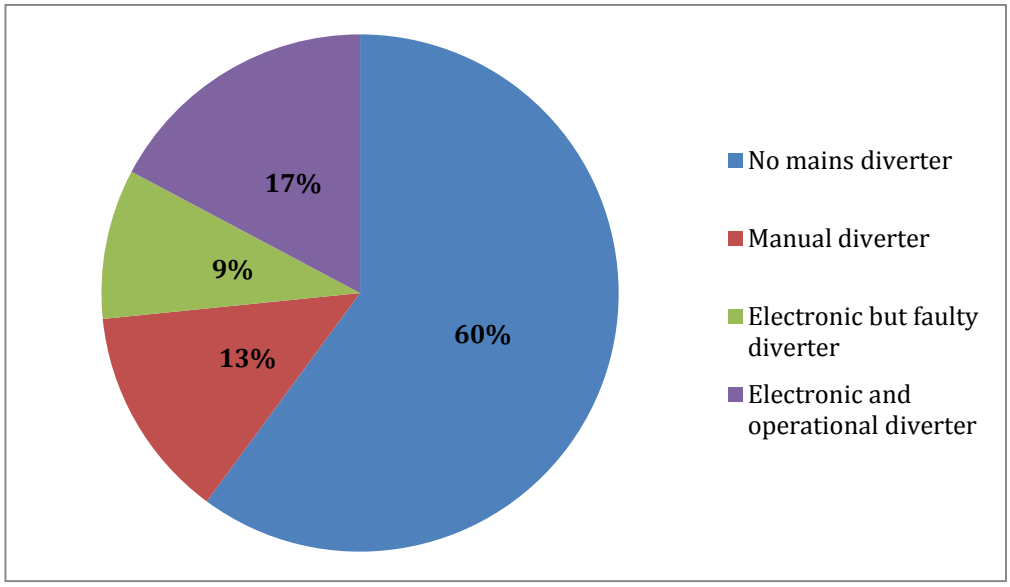
was that among the 54 dwellings with tank systems with electronic diverters, at least 52% had failed at least once and 35% were not operational at the time of inspection (Table 19). Figure 34 summarizes the information about diverters.

Figure 34: Summary of diverter information - percentages of diverter types and functionality

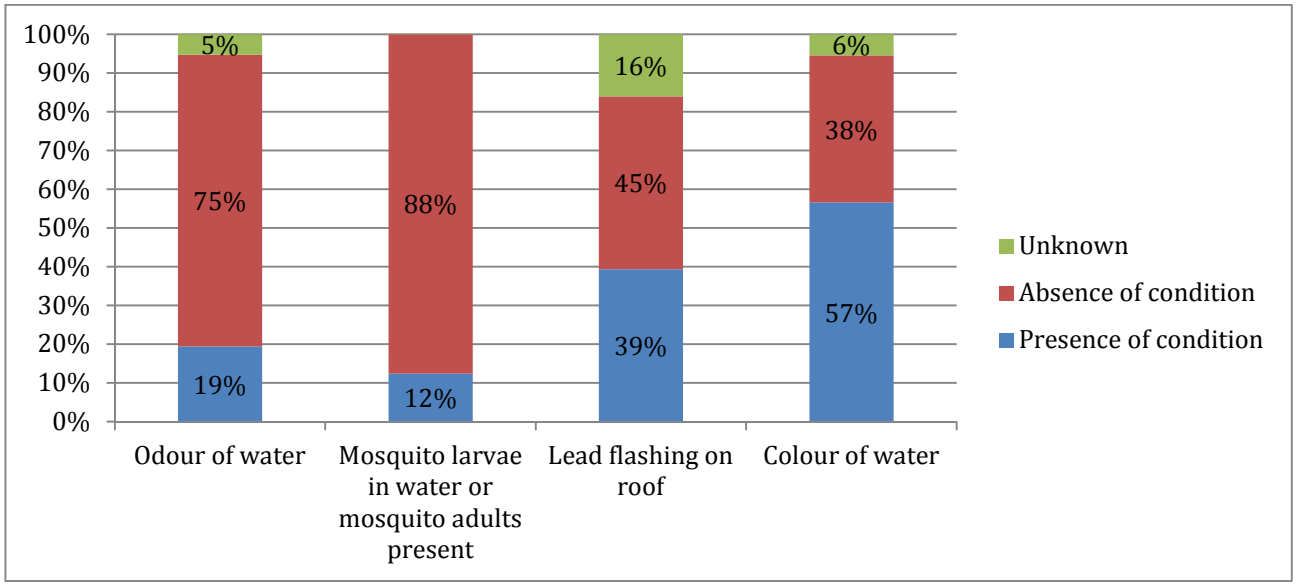
Among tank owners, 50% used the water for washing machine supply and 98% for toilet supply (Table 9), and thus would value the rainwater aesthetics. The concentration of sediment in rainwater was low, medium and high for 64%, 17% and 8% of tanks, respectively (Table 22). In addition, 57% of tanks had discolored water (Table 23) and 19% had odorous water (Table 21). Approximately 14% and 9% of tank owners use the rainwater for bathing and cooking/drinking (Table 9), and hence water quality and health risk mitigation would be important for those end uses. Mosquito larvae were detected in 12.5% of tanks. In addition, 39% of dwellings had lead flashing in their roofs (Table 23 and Table 13), which can cause lead contamination of rainwater. The presence or absence of various water quality issues are summarized in Figure 35.

Figure 35: Summary info on water quality issues

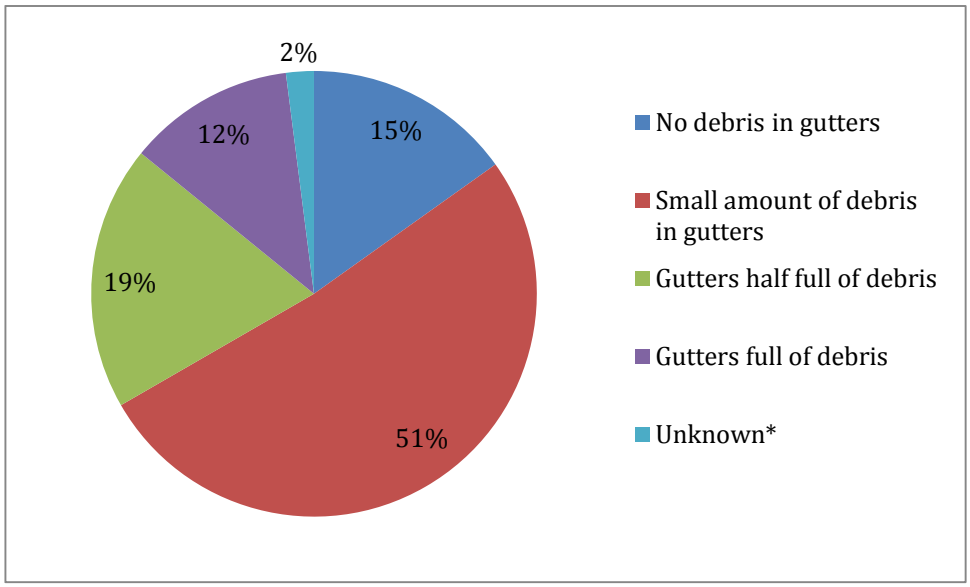
Figure 36: Quantity of debris in gutters

*__Note__: In some locations, primarily due to access problems or covered gutters, it was not possible to evaluate the quantity of debris. In all other cases, the amount was judged based on a video recording along the gutter.

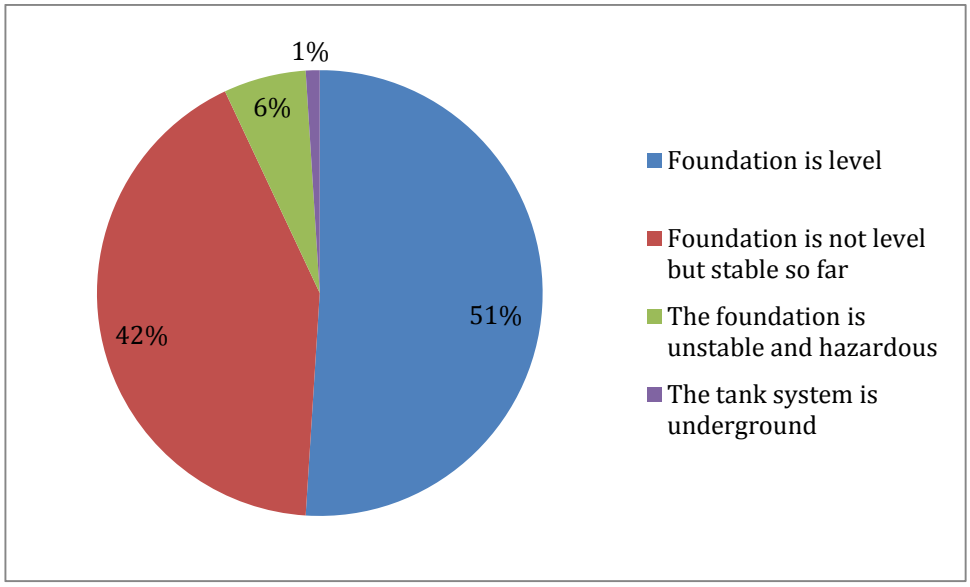
The stability of a tank is dependent on its foundations. Figure 37 shows that 51% of tanks were on level foundations, 42% were on unleveled foundations but were stable and 6% were on hazardous foundations. Hence whilst majority of tanks appeared stable, the foundations of half of the tanks were not level as they should have been. Majority of the tanks inspected were self-standing (Figure 37). Of greater concern was that 13% of tanks were leaning against a structure, thus adding increased lateral strain onto it (Figure 38).

Figure 37: Tank foundations being level or unstable

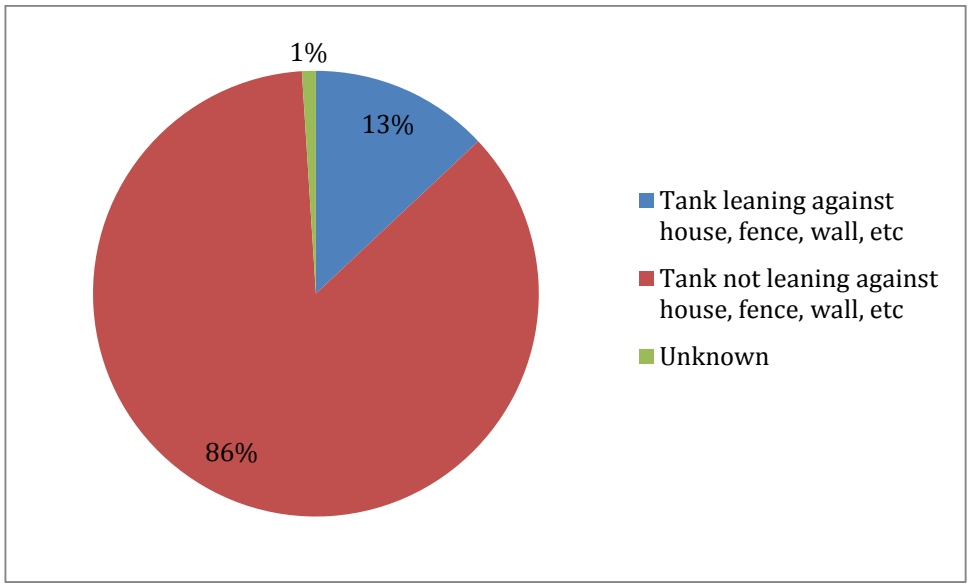
Figure 38: Tanks leaning against objects

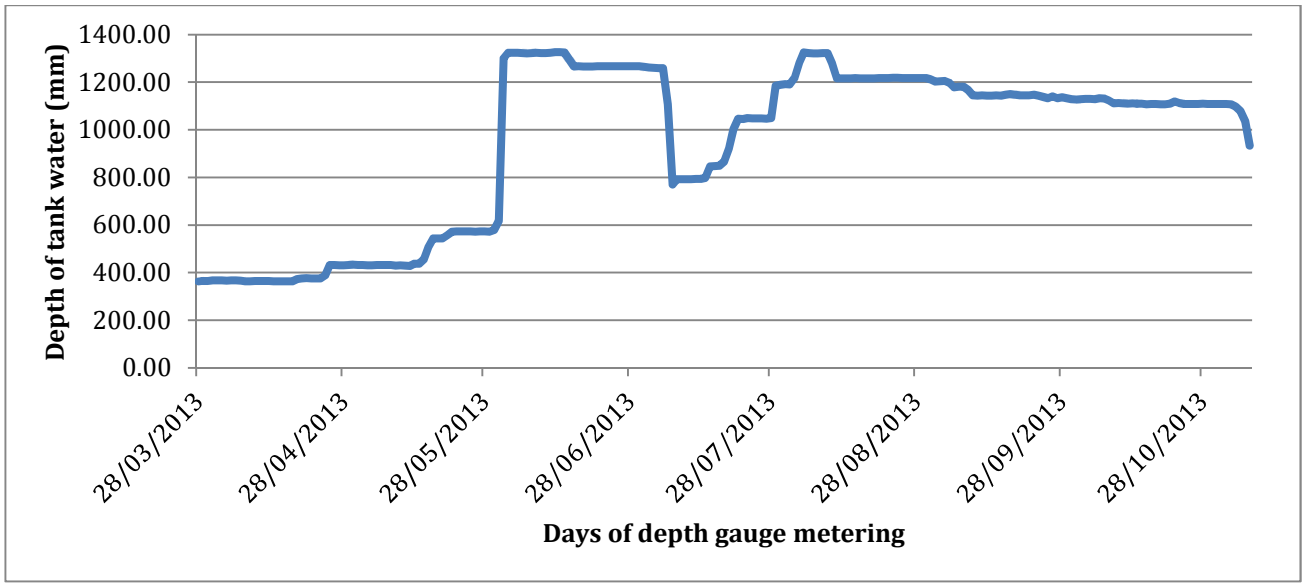
Figure 59: Depth gauge data (Site 3)*

For the months of data where there are both depth gauge measurements and flow meter measurements, the flow meters estimate rainwater use at 0.28 kL and estimates based on the depth gauges indicate a rainwater use at 0.46 kL (the difference being 0.18 kL). However, much of the difference is due to a single usage event in July which depth gauges picked up, but which flow meters did not pick up. The volume of this usage event was approximately 0.24 kL. This event is likely to have been either due to leakage or at least water exiting the tank through a non-metered point. Depth gauge

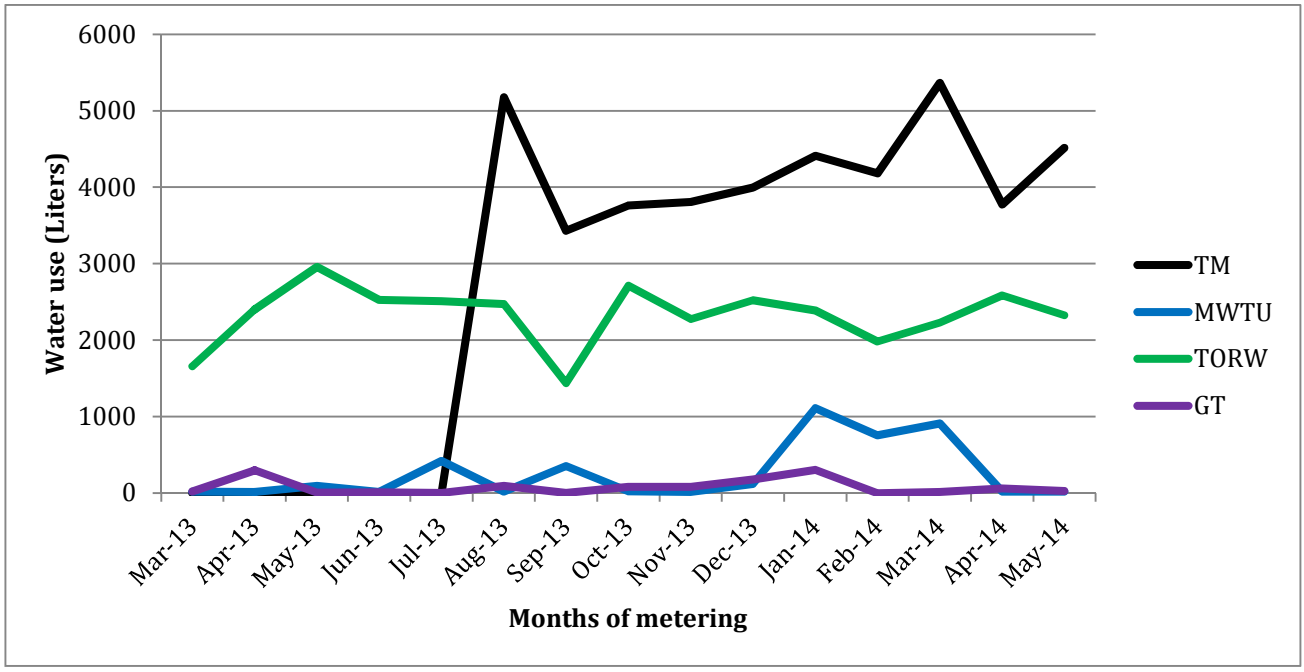
Figure 65: Monthly profiles - site 5

As seen in Figure 65, the total mains meter was not functional until around August 2013. Mains water topup had a number of events in July and September 2013 and then over the summer at a number of instances. The total amount of mains water topup is still relatively small compared to rainwater use. As seen in Figure 64, the patterns of mains water use are rather different to rainwater use. The total

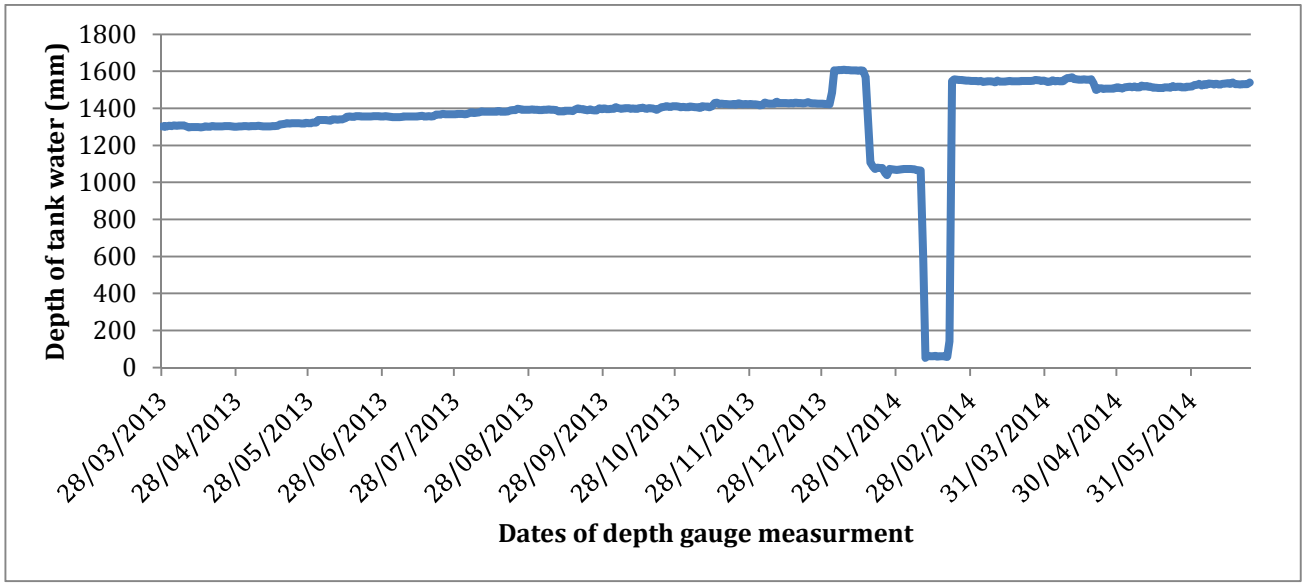
Figure 71: Depth of tank water - site 7

Estimates of rainwater use based on depth gauge measurements for the period of April 2013 – May 2014 are 3.5 kL and this aligns well with estimates based on flow meter data. Figure 71 shows clearly that rainwater has been used only at a limited number of times; primarily during the summer months.

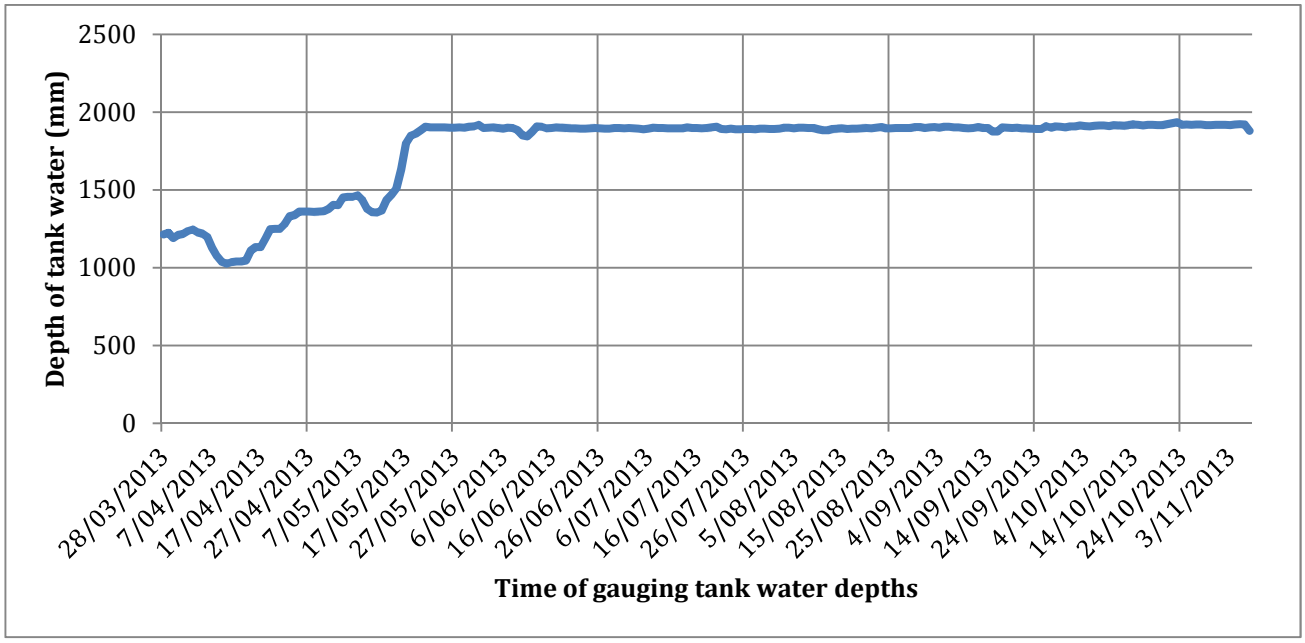
Figure 74: Depth gauge levels site 8

Figure 74 shows that the tank was about 60% full when metering started. The depth gauge data seems to indicate some legitimate rainwater use (i.e. rainwater as opposed to tank water demand being met by mains water from the switch) at a few times in this first month of metering, and this is backed up by the flow meter data. By middle of May the tank seems to have filled up – and subsequently the level never dropped below being nearly full. This time period is also indicated in the flow metering data by all tank water being met by the automatic mains switch.

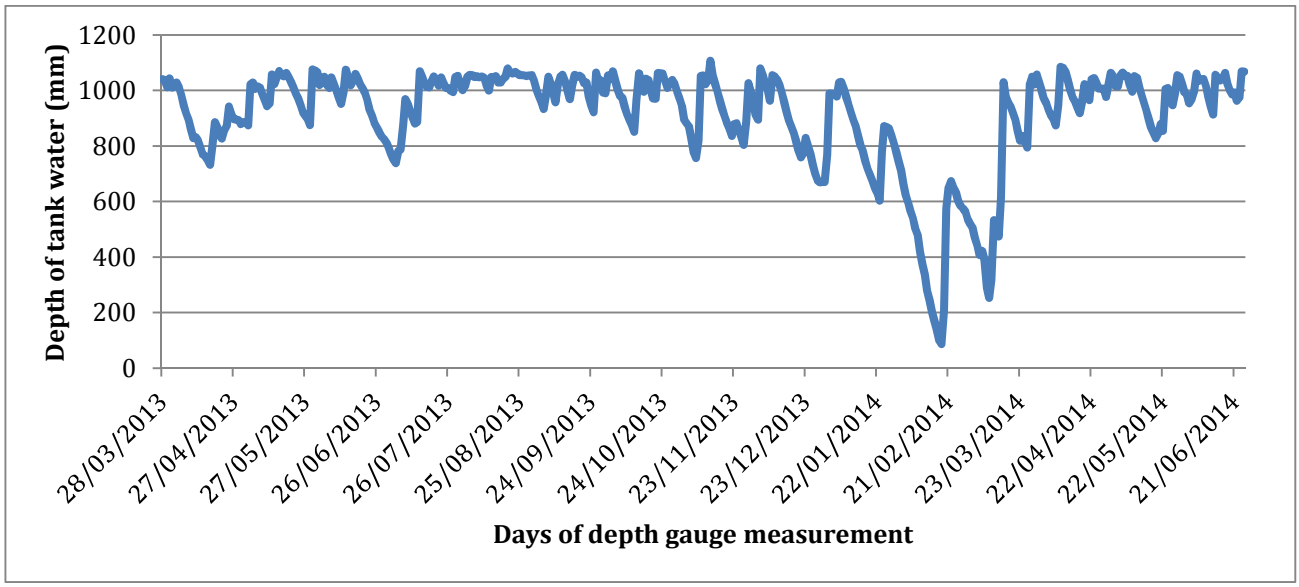
Figure 101: Depth of tank water site 18

The specific energy for the pump in this site is relatively high. It is noted that 42% of the energy used by the pump was single pulses with no water use, i.e. with the pump in standby mode. When this standby energy is excluded, the specific energy is at the lower end of the normal range (1 kWh/kL). As can be seen per Figure 101 this tank shows regular use and has been within 50 mm of being full (i.e. depth of tank water >= 1056 mm) for only 7% of the time. The time when the tank was nearly empty in February 2014 also coincides with the incident according to flow meters when the automatic switch was activated. This indicates that the automatic switch is indeed fully functional.

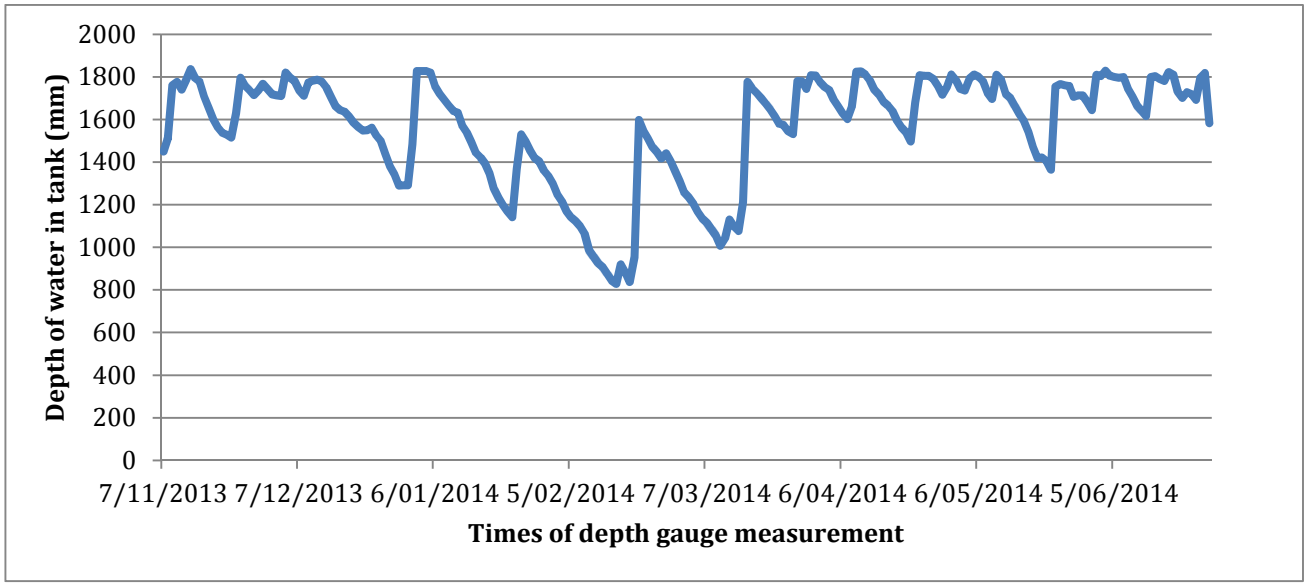
Figure 104: Depth gauge measurements site 19

There are depth gauge measurements for this site from November 2013 onwards, as per Figure 104 which shows the daily water levels throughout the measurement period. It is notable that the tank has not run dry and that there are regular withdrawals of water from the tank. Only about 16% of the time has the tank been within 50 mm of being full. The depth gauge data can again be used to estimate rainwater use from the tank (using an error margin of 5 mm and an estimated base area of 0.51 m^2) and again we find a slight discrepancy between that which is being measured with flow meters and that which is being measured with depth gauges, as per Figure 105.

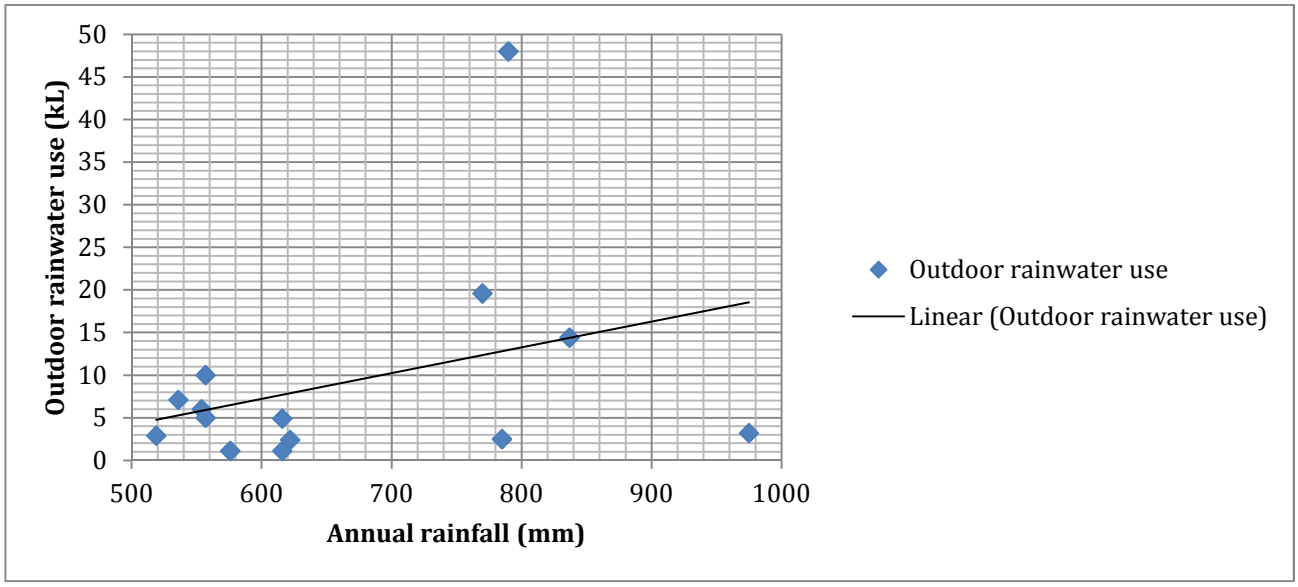
Figure 114: Relationship between annual rainfall and outdoor rainwater use

The link between rainfall and rainwater use potential is explored in Table 56. Contrary to what could be expected if the rainwater use was demand driven (less rainfall means more demand for gardening), as can be seen in Figure 114, there is a weak relationship between rainfall and outdoor rainwater use. This trends towards rainwater use being supply driven could be explained by the observation that for most tanks, the only times that tanks have run dry has been in the dry summer months when outdoor watering activities are most prevalent. This is also consistent with the observation that the relationship between rainfall and indoor water use is virtually non-existent, as per Figure 115. This again reinforces the notion that tanks will primarily only become empty during the hot dry summer months; often in response to high levels of outdoor water usage.
